# ALTON FLOOD MEADOWS

## MANAGEMENT PLAN

**ALTON TOWN COUNCIL**

September 2022

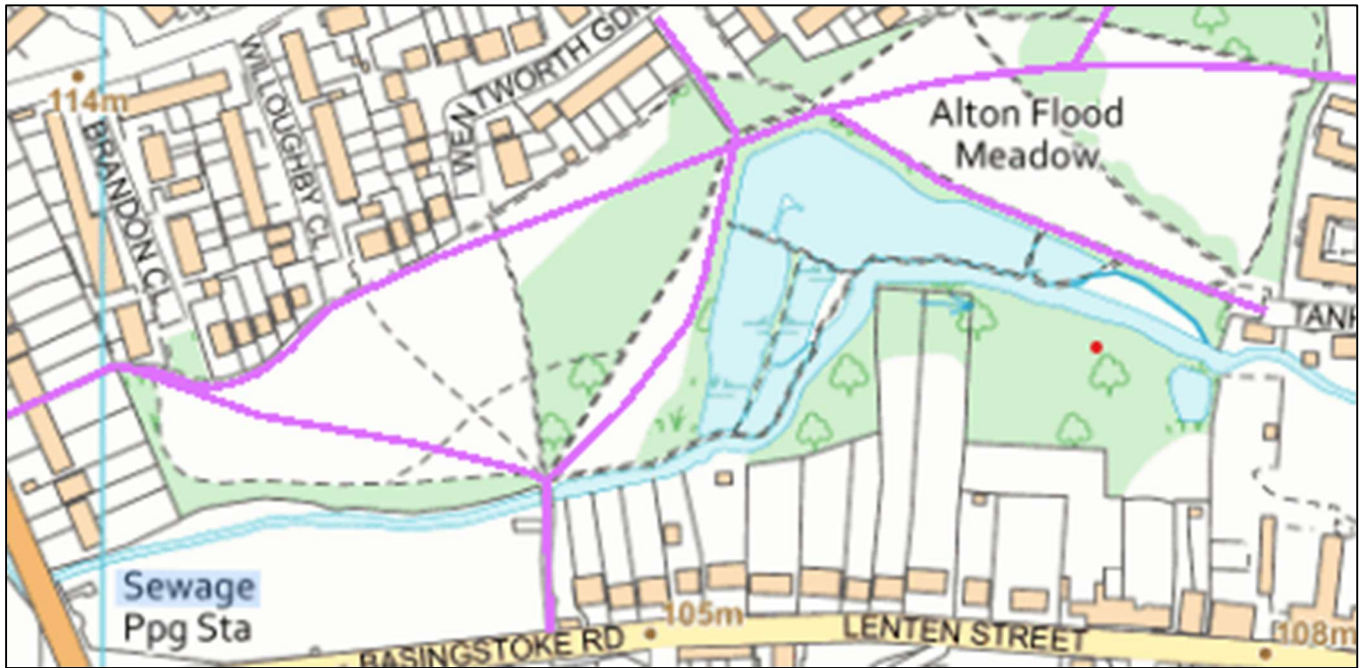
A number of public rights of way cross the site (shown in map below). All these public rights of way are footpaths. There are several other formal paths across the site. There is an area of grassland and both banks of the river in the southwest corner of the site which is owned by South East Water.

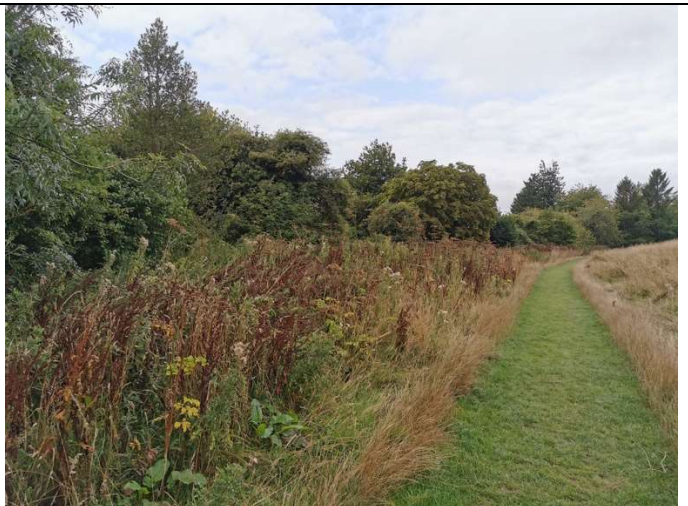
Plate 2 – Wildflower area

The creation of a wildflower area/meadow was recently attempted in 2019 along the south western edge of the park but due to the management involved with establishing a wildflower area, the area has become overgrown with vigorous grassland species. Wildflower planting should be monitored to evaluate the suitability of the planting, with further sowing adjusted accordingly. Management of this area should be undertaken in-line with the actions listed above.

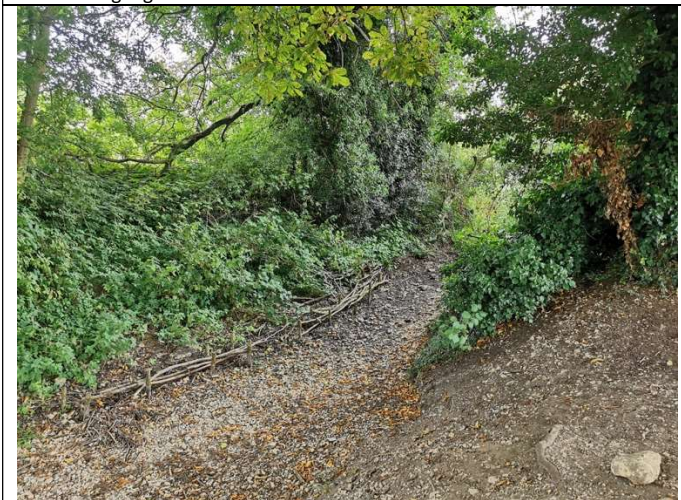
Plate 3 – Berm in need of repair upstream of Lenten Street Bridge

The berms installed upstream of Lenten Street Bridge are in need of repair and enhancement.

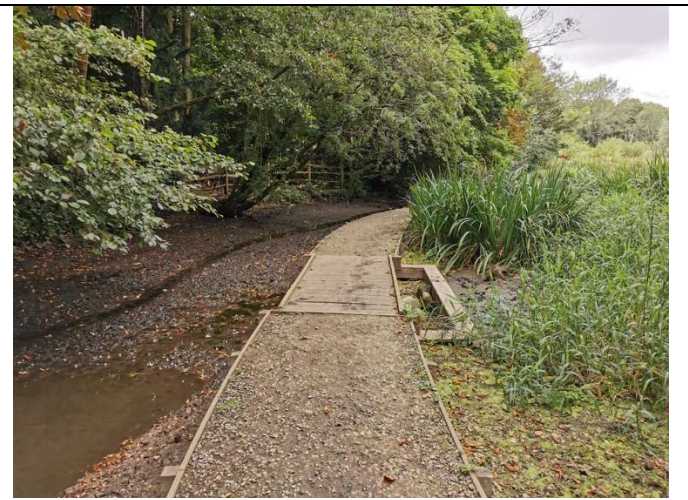
Plate 4 – Newly installed riverside raised path and recycled plastic footbridge

A hardstanding path is present along the river and watercress beds. A section of the riverside/watercress bed path has been raised and repaired including the installation of new recycled plastic footbridges, further improvements to the remainder of this path are planned by Alton Town Council. The tarmac hard surfaced paths that cross the park have deteriorated in places and are in need of repair.

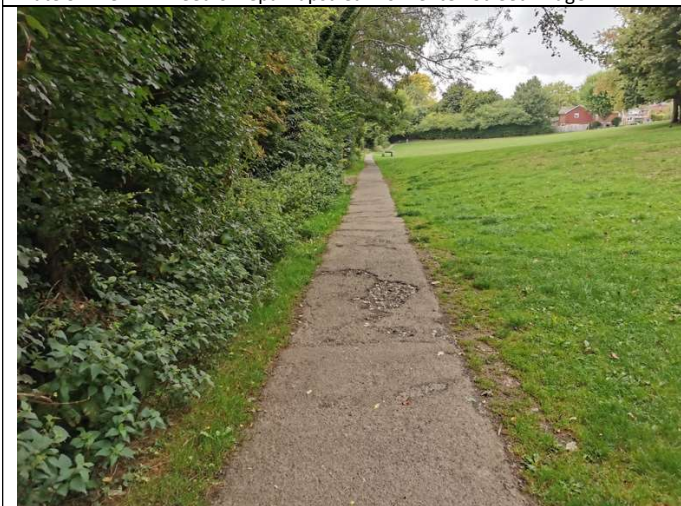
Plate 5 – Tanhouse Lane path repair

Maintenance to the existing paths should be carried out as they are failing in places and are uneven. Particular attention should be paid to the path leading to the Tanhouse Lane entrance where severe deterioration is present.

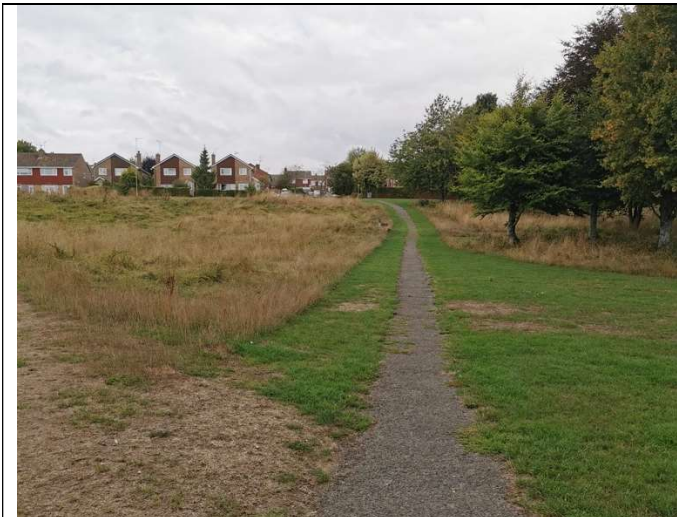
Plate 7 – Lenten Street to Wentworth Close Path

The path from Lenten Street to Wentworth Gardens is narrow and is in need of widening works in order to improve access for wheelchair and mobility vehicles.

*Installation of 120m x 1.5m wide asphalt footpath from Lenten Street to Wentworth Gardens:*

Removal of existing path = £7,200.00

Installation of new 1.5m wide footpath with 100mm sub-base, 50mm binding course, 50mm surface course and 50mm x 150mm pre cast concrete edging = £13,150.00

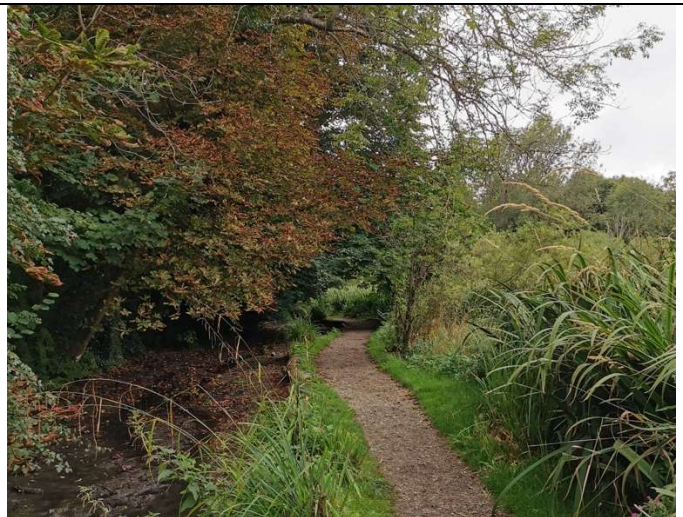
Plate 8 – Existing riverside path

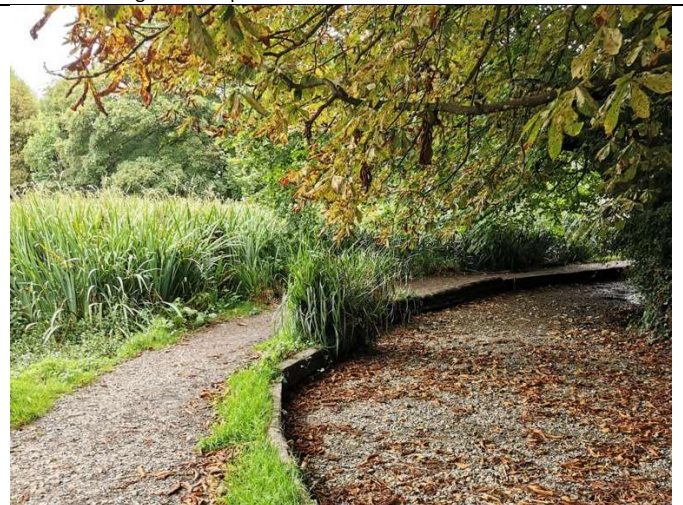
Plate 10 – Riverside path in need of raising and updating

The river/watercress bed path and bank should be repaired and raised in keeping with the newly repaired section of path/bank. This will ensure it is accessible all year round even during flood events.

Approximately 100m of Oak post and plank revetment, backfilled and topped with compacted MOT Type 1 = £45,000.00

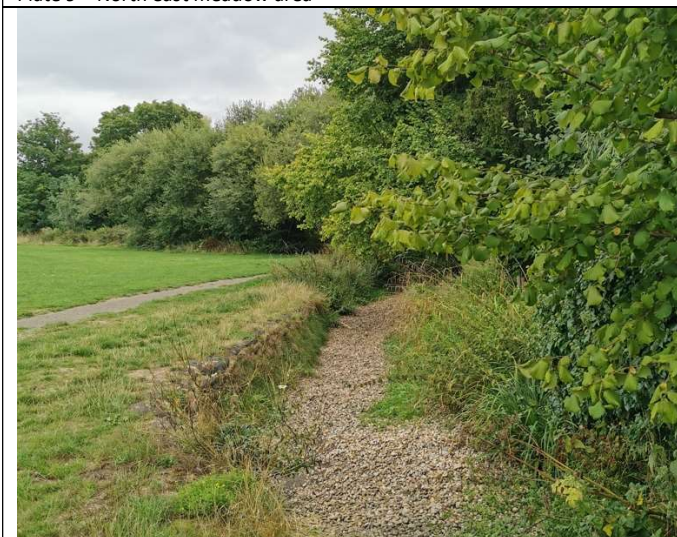
Plate 11 – Recent gravel recharge downstream of Lenten Street Bridge

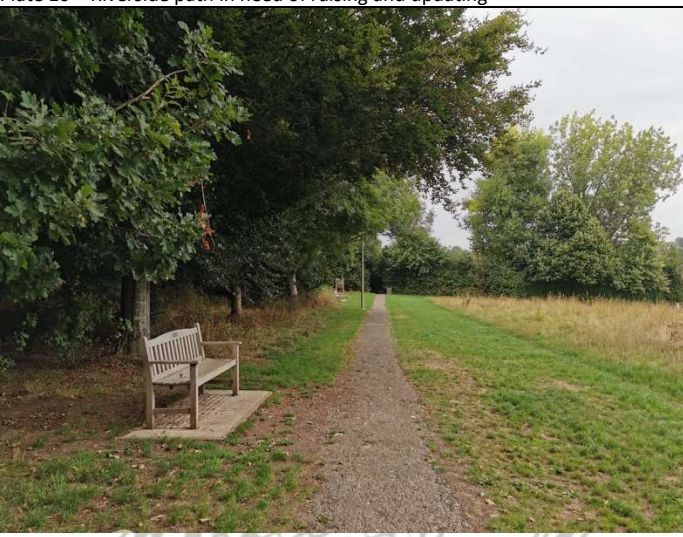
Plate 12 – North east section path showing street furniture

Access points and paths across the site need to be maintained in a safe and useable condition.
