# WILL HALL MEADOW, MANAGEMENT PLAN

**ALTON TOWN COUNCIL**

**February 2022**

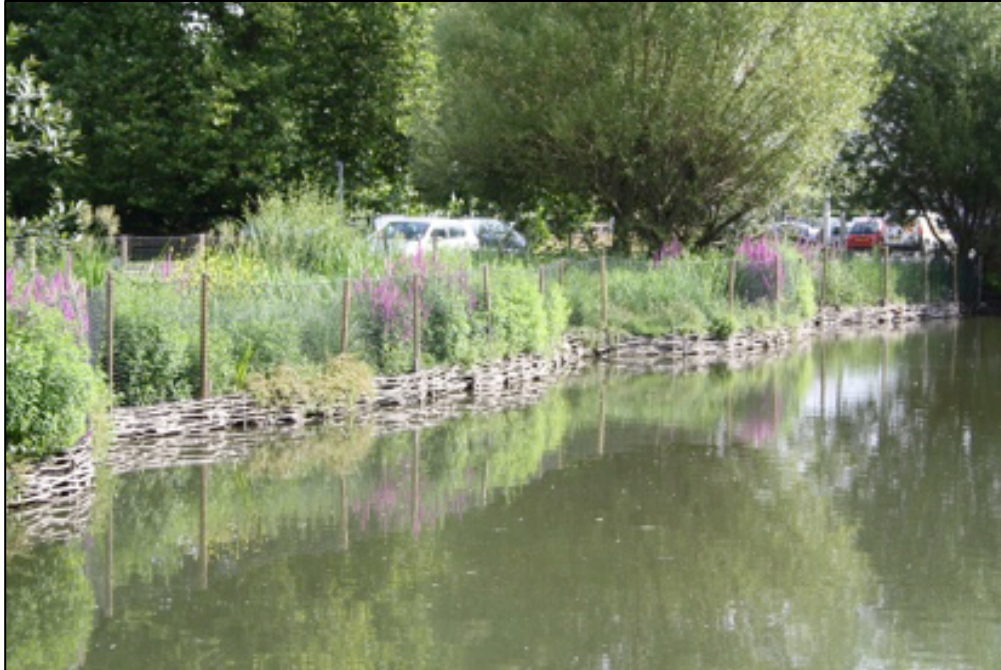
It is recommended that this area is sympathetically fenced to prevent access from visitors and dogs which will allow wildlife to flourish in this unique habitat (Works Prog Ref ML01). Fencing should consist of 50mm x 50mm polypropylene fencing tensioned across chestnut posts (please see picture below).

50mm x 3mm x 1m black polypropylene netting tensioned across chestnut posts.

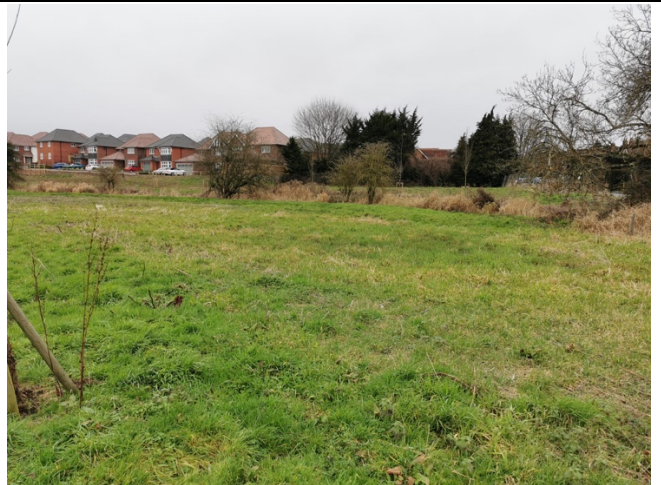
Plate 2 – Eastern marshland area.

The area of marshland/wetland in the eastern area of the meadow should be retained with minimum human interference required.

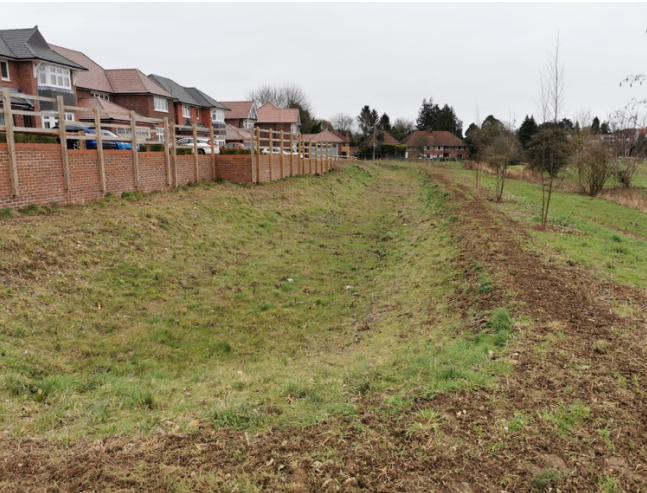
Plate 3 – SuDS attenuation pond site

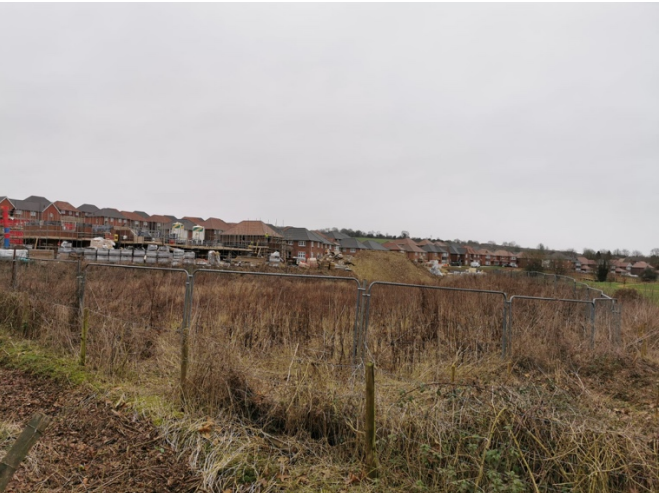
Plate 4 – Location of large SuDS attenuation pond

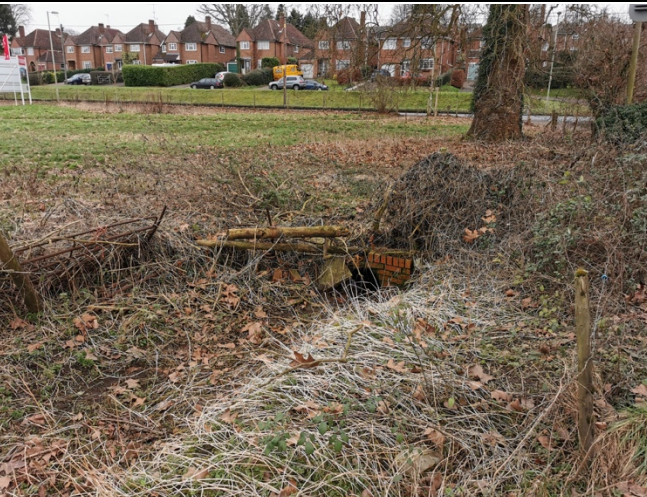
Water flow is not a permanent feature with the stream usually drying up in the summer and autumn months. The stream is considered a winterbourne. Flows are also supplemented by surface water run-off from local agricultural fields, housing and road drainage, most notably the ditch that enters from Brick Kiln Lane.

Plate 5 – Brick Kiln Lane ditch and culvert into Will Hall Meadow

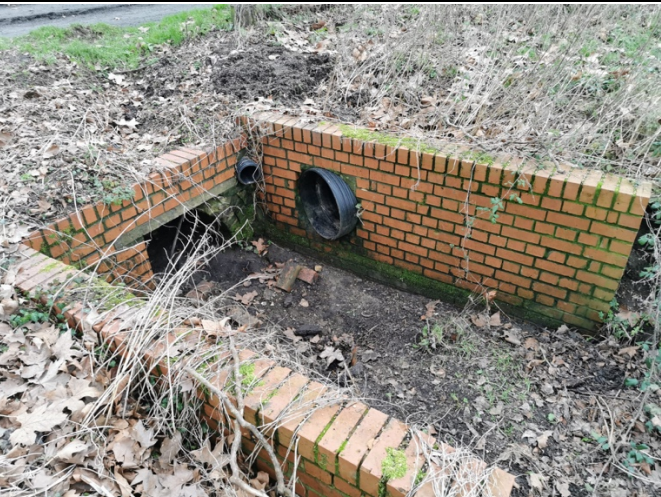
Plate 6 – Brick Kiln Lane Culvert Structure

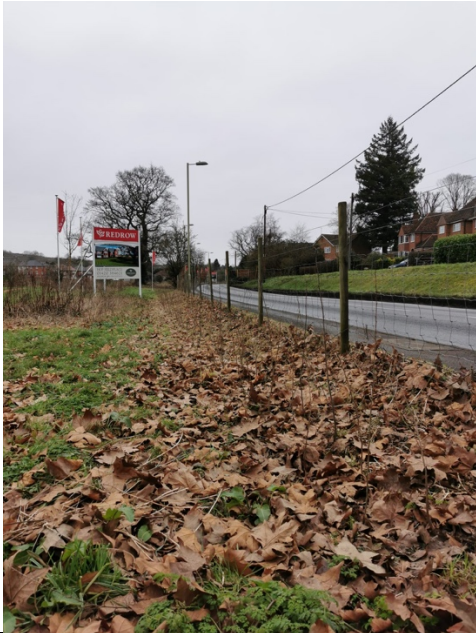
Hedgerows bordering the site are modern, with the hedgerow bordering the Basingstoke Road limit planted in January 2022 with 1800 whips.

- It has been noted that the hedgerow has been planted too close to the existing fence line in order to be maintained to the standards mentioned above. Once the hedgerow has established, replacement or relocation of the fence line should be considered.

Plate 7 – Newly planted hedgerow along Basingstoke Road boundary

- Hedgerows should be maintained to encourage development of tall, dense, bushy structure. Trimming of hedgerows should manage 'A' or dome shaped with no vertical sides (Works Prog Ref TS05).

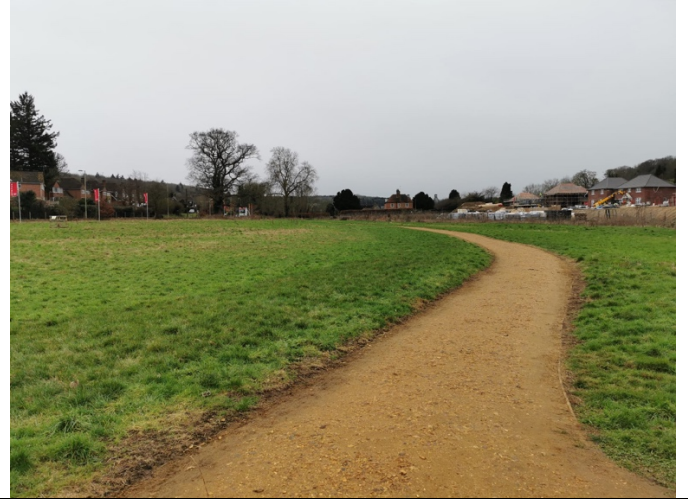
Situated in the floodplain the meadow is dominated by common grass species typical of agricultural use. Agricultural use in recent years has degraded what once would have been a floristically diverse floodplain meadow.

Plate 10 – Showing current single species grass dominance

Cutting is an effective method of managing grassland because the timing, area and height of the cut can be easily adapted to suit the site.

In most situations, June or July (Spring/summer cut) is the best time for cutting, with a further cut in September/October (Autumn/winter cut) often being beneficial. However, cutting times can be varied to suit local conditions. A spring cut (Works Prog Ref FM01) knocks back thistles and vigorous grasses that can sometimes take hold during the winter. While an autumn cut allows the grassland plants more opportunity to flower and set seed (Works Prog Ref FM02 & FM03).

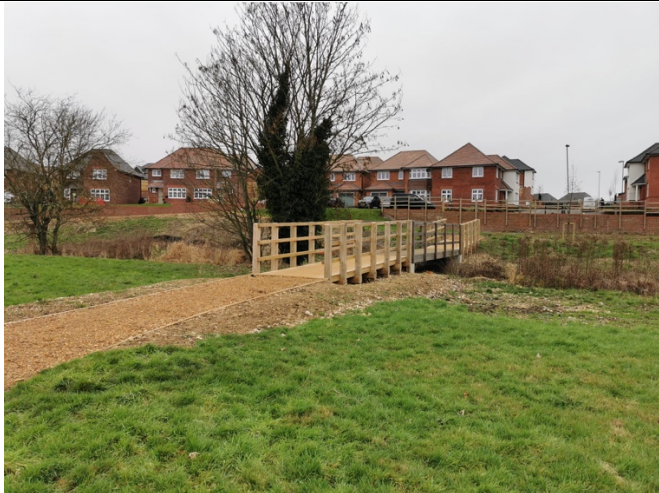
A timber edged compacted aggregate path has been installed which connects all access points. A bridge has been installed to allow access to the meadow from the Minstrel Close entrance.

Plate 11 – Footbridge connecting Will Hall Meadow to Minstrel Close

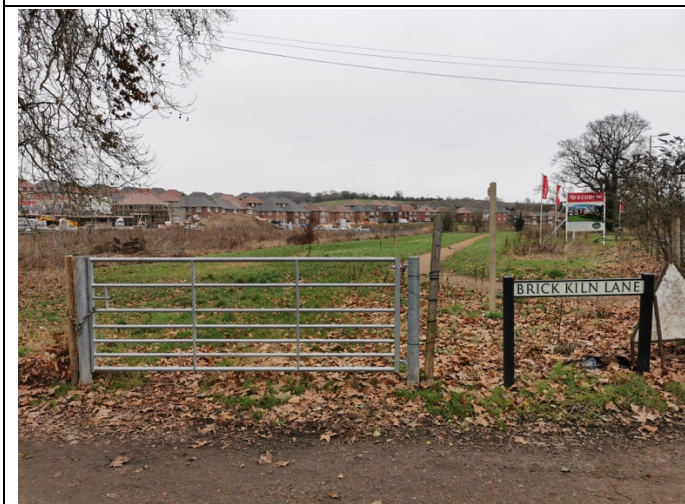
Plate 17 – Brick Kiln Lane vehicle access

Further discussion with Alton Town Council is required in relation to the installation of a new access point and footpath entrance from Brick Kiln Lane. It has been recommended that this should consist of a vehicle access point and an entrance that is pedestrian, wheelchair and cycle friendly.

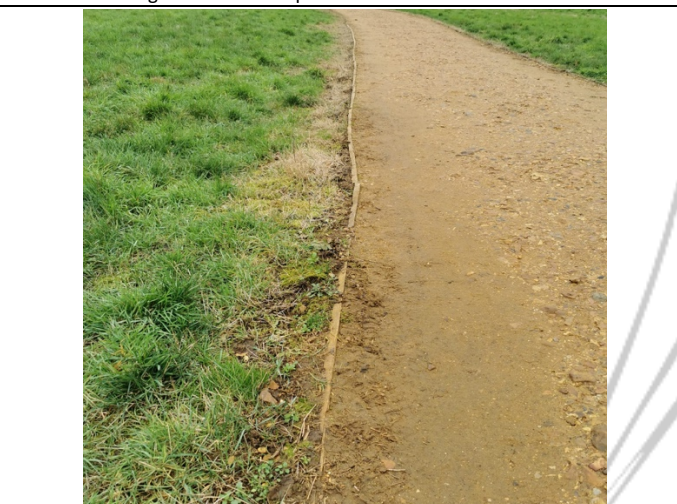
Maintenance to the existing path should be carried out as the timber edging is failing in places and is uneven. It is recommended that the timber path edging is replaced with a recycled plastic profile to aid longevity. The existing path should be used as a base and a more aesthetically pleasing and hard wearing self-binding topping should be applied.

Plate 18 – Footpath edging in need of repair

Recycled plastic path edging (in keeping with boardwalk), existing MOT Type 1 path to be used as base, topped with 50mm self-binding path gravel. Approximately 200m x 2m.
