# A Management Plan for King's Pond, Alton, Hampshire.

John Underhill-Day & Chris Panter

Date: November 2017

Recommended Citation: Underhill-Day, J. C. & Panter, C., 2017. A Management Plan for King's Pond, Alton, Hants. Unpublished Report to Alton Town Council.

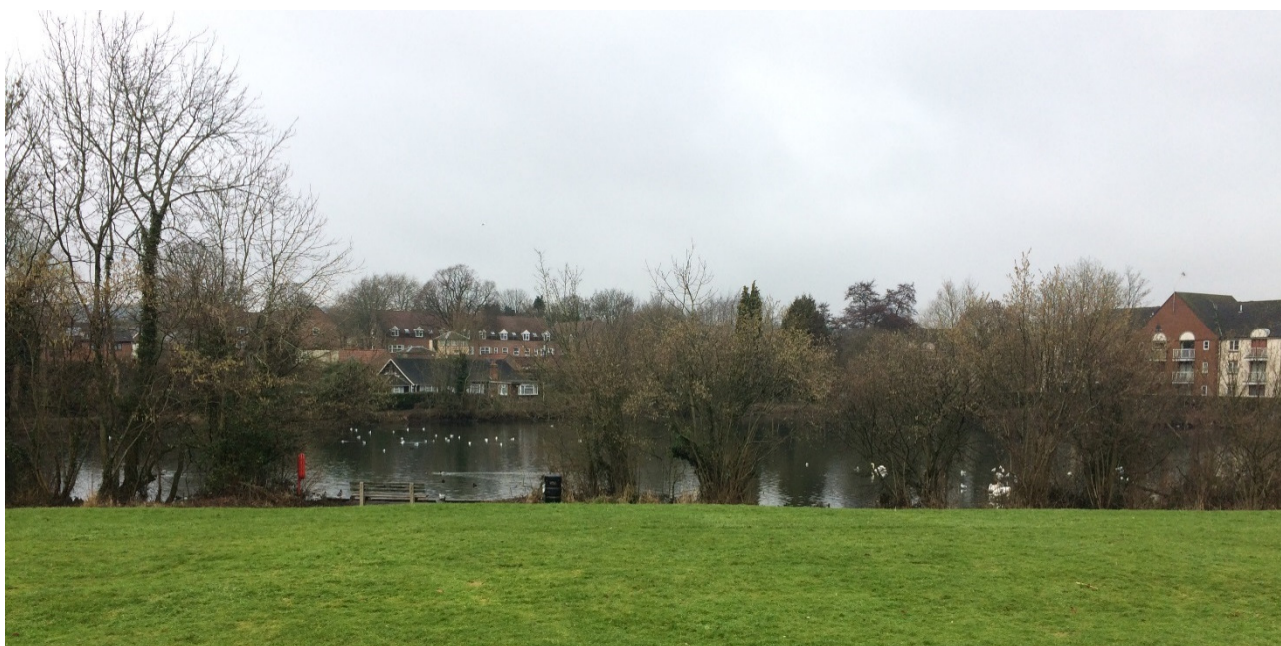
- 1.1 King's Pond is located in the heart of Alton (Grid Ref SU723395) with access off Lower Turk Street and its extension which becomes Ashdell Road to the south-east. The site is bounded to the north-west by the Mid Hants Railway Line and to the north-east by developments fronting Paper Mill Lane. The site is c. 4.1 ha in extent.

- 1.2 The site is owned by Alton Town Council who also own an old chalk pit to the south of Ashdell Road and the King's Pond Bungalows to the north, neither of which is included in this plan (see Map 1). There are three properties fronting Lower Turk Street which back onto the site and both they and the road may have surface water drains which discharge into King's Pond, although there do not appear to be any formal arrangements to do so.

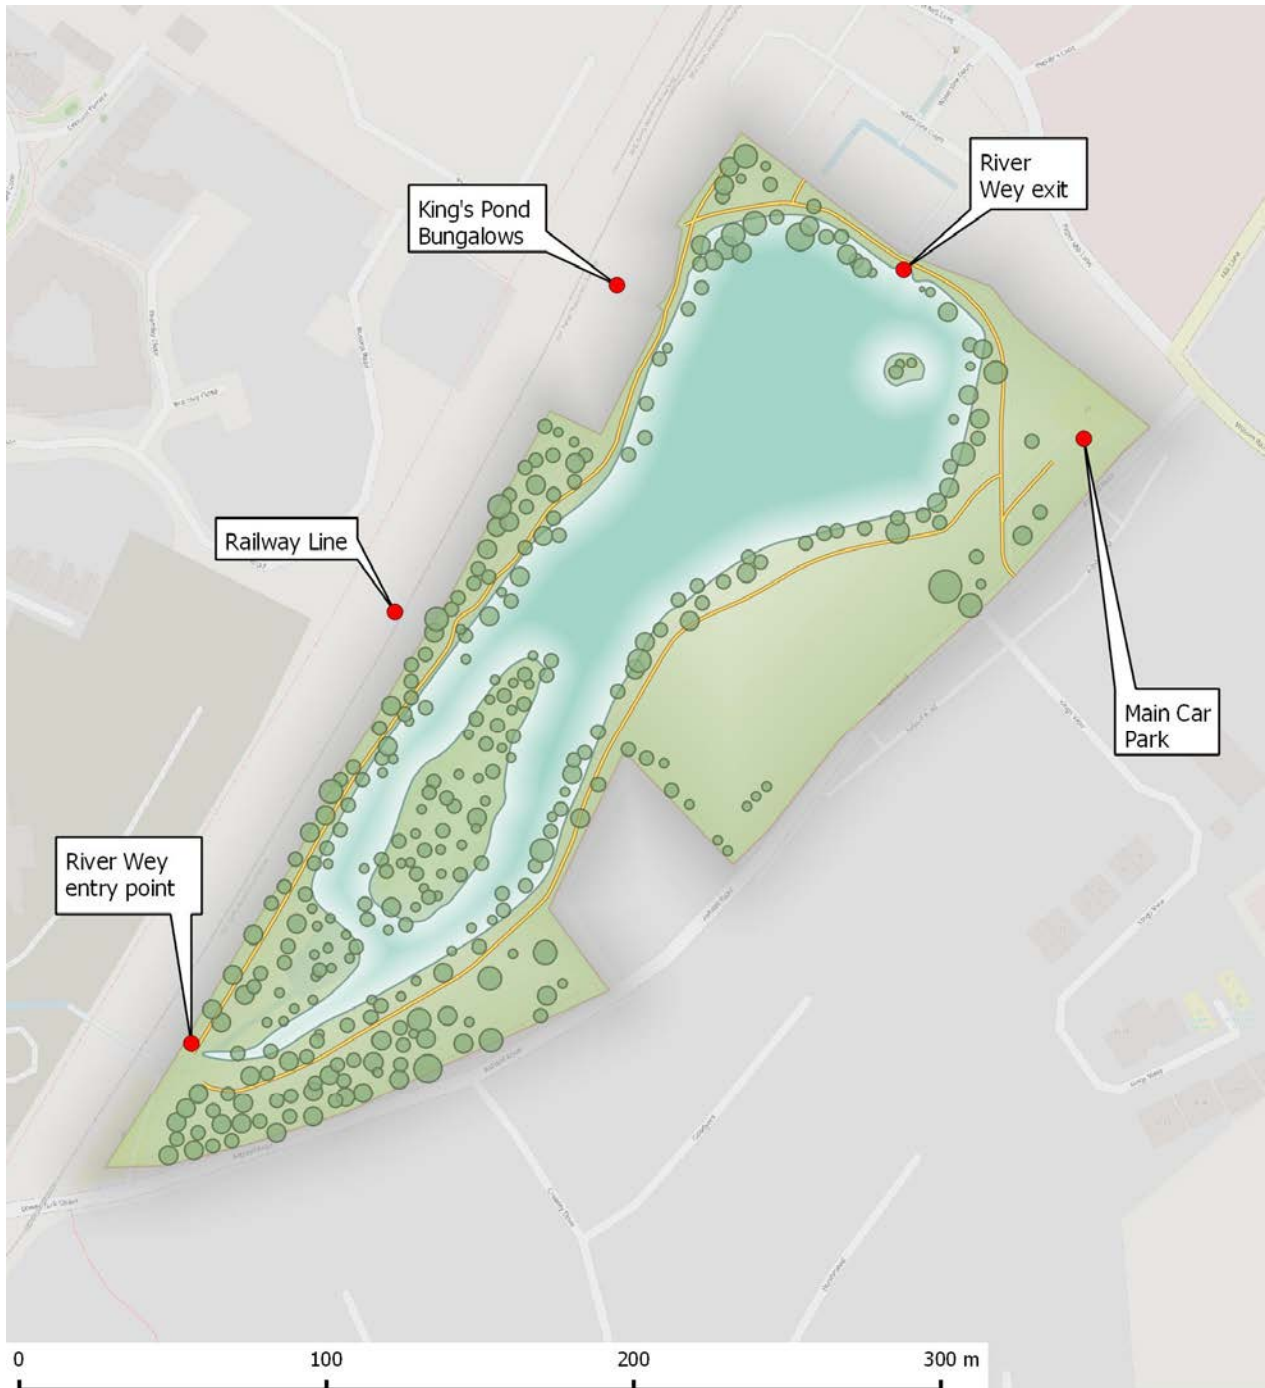
## Maps and aerial photographs

1.5 The area is covered by OS 1:25,000 (No 133) and 1:50,000 OS sheet 186
