# KINGS POND, ALTON

## DRAFT MANAGEMENT PLAN

**ALTON TOWN COUNCIL**

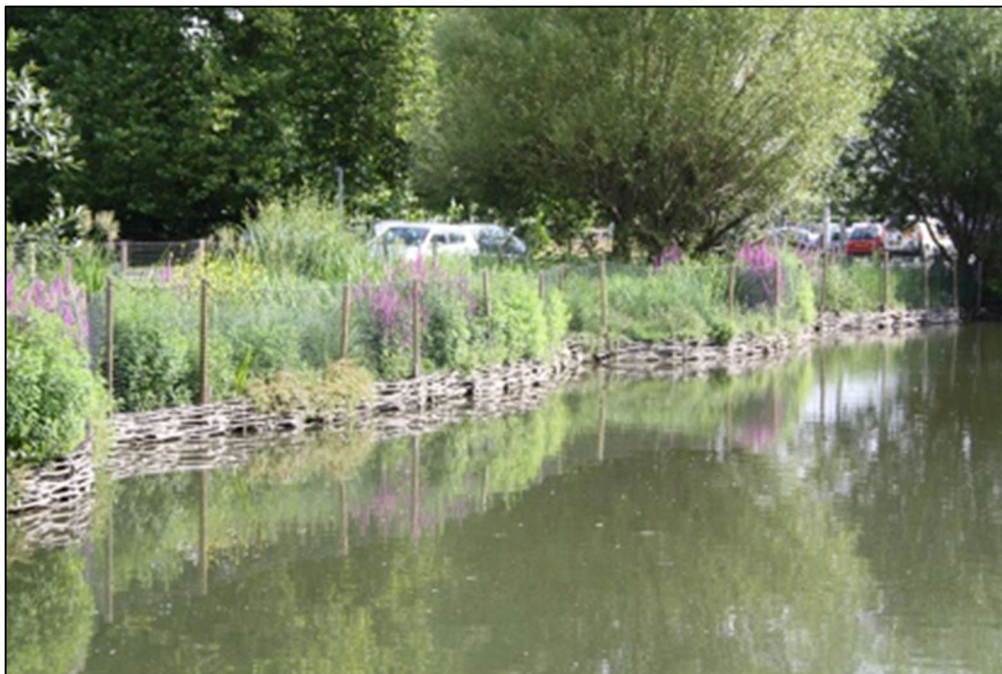
It is recommended that this area is sympathetically fenced to prevent access from visitors and dogs which will allow wildlife to flourish (Works Prog Ref CA01). Fencing should consist of 50mm x 50mm polypropylene fencing tensioned across chestnut posts (please see picture below).

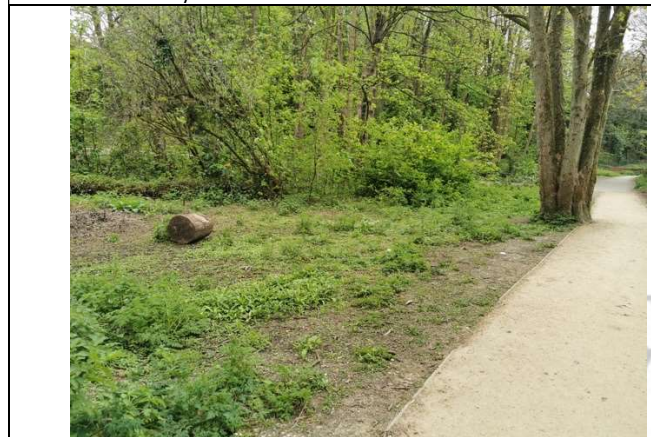
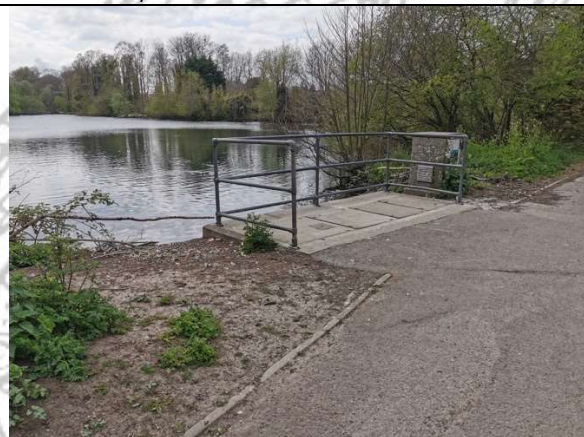
Plate 3 – Proposed conservation area

A conservation area is to be considered in an area identified near the path at the south west end of the pond. The conservation areas should be periodically managed but minimum human interference is required.

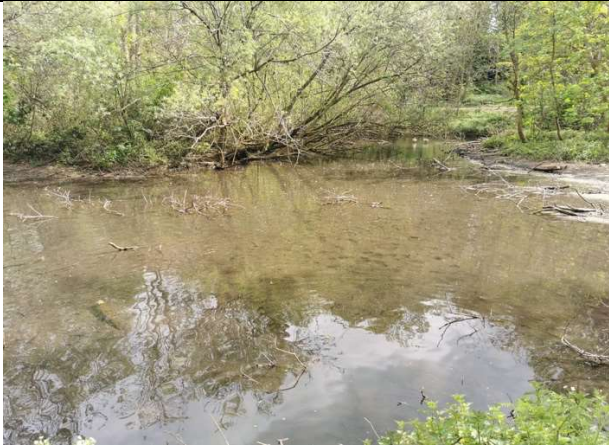
Plate 13 – Siltation at south west end of pond

Due to the impoundment caused by the damming of the river the pond acts as a natural silt trap as the sediment load carried in the water settles out in slower flows. Being a headwater stream the discharge and velocity regularly changes. The pond has been dredged twice in the past in order to reduce silt levels within the pond.

- Mechanically remove silt (dredge) in order to reduce levels. Arisings can be used in the creation of islands, new sections of bank and to repair eroded bank edges (Works Prog Ref RS01).
- Continue to educate members of the public about the adverse effects of feeding wildfowl (Works Prog Ref RS02).
- Carry out survey of bank erosion and areas of need of immediate repair (Works Prog Ref RS03). See section 2.6.
- Locate and redirect highways surface water drains and outlets from adjoining properties (Works Prog Ref RS04).
- Consider the removal of a number of the Canada Geese from the site, either through culling, translocation or any other option identified to reduce the population and reduce nutrient loading.
